AUGUST 19, 2013
BACKFLOW PREVENTION

.FARNHAM

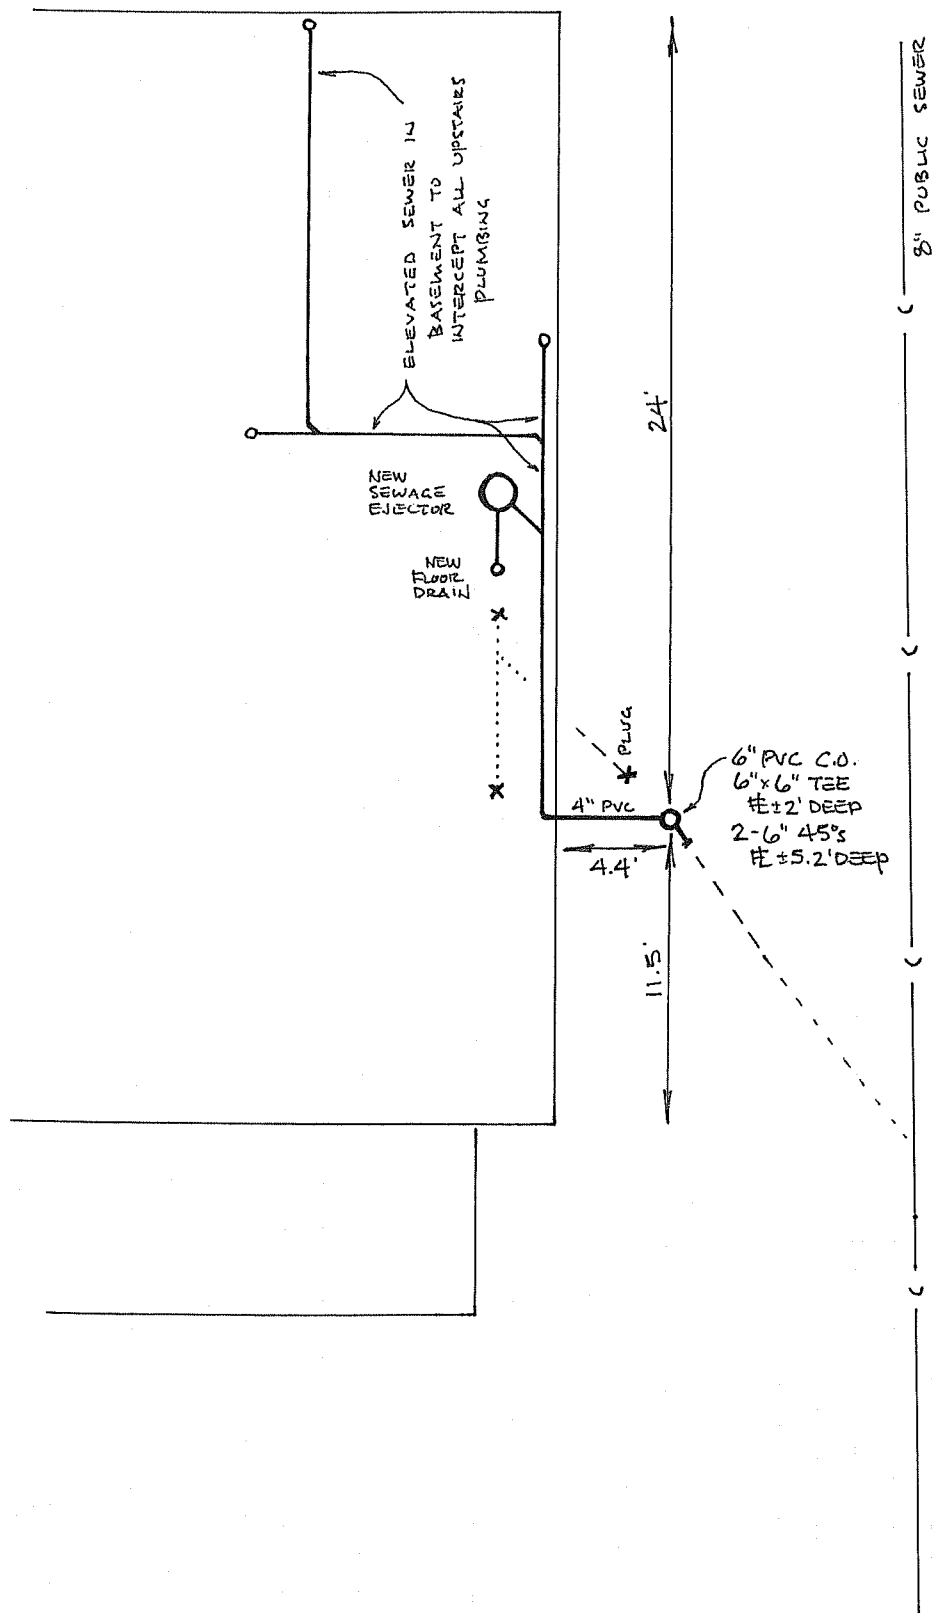
Basement wall is
breached

Full-sized
cleanout

New elevated
piping

Old building sewer
service line is capped

Vertical
riser pipe

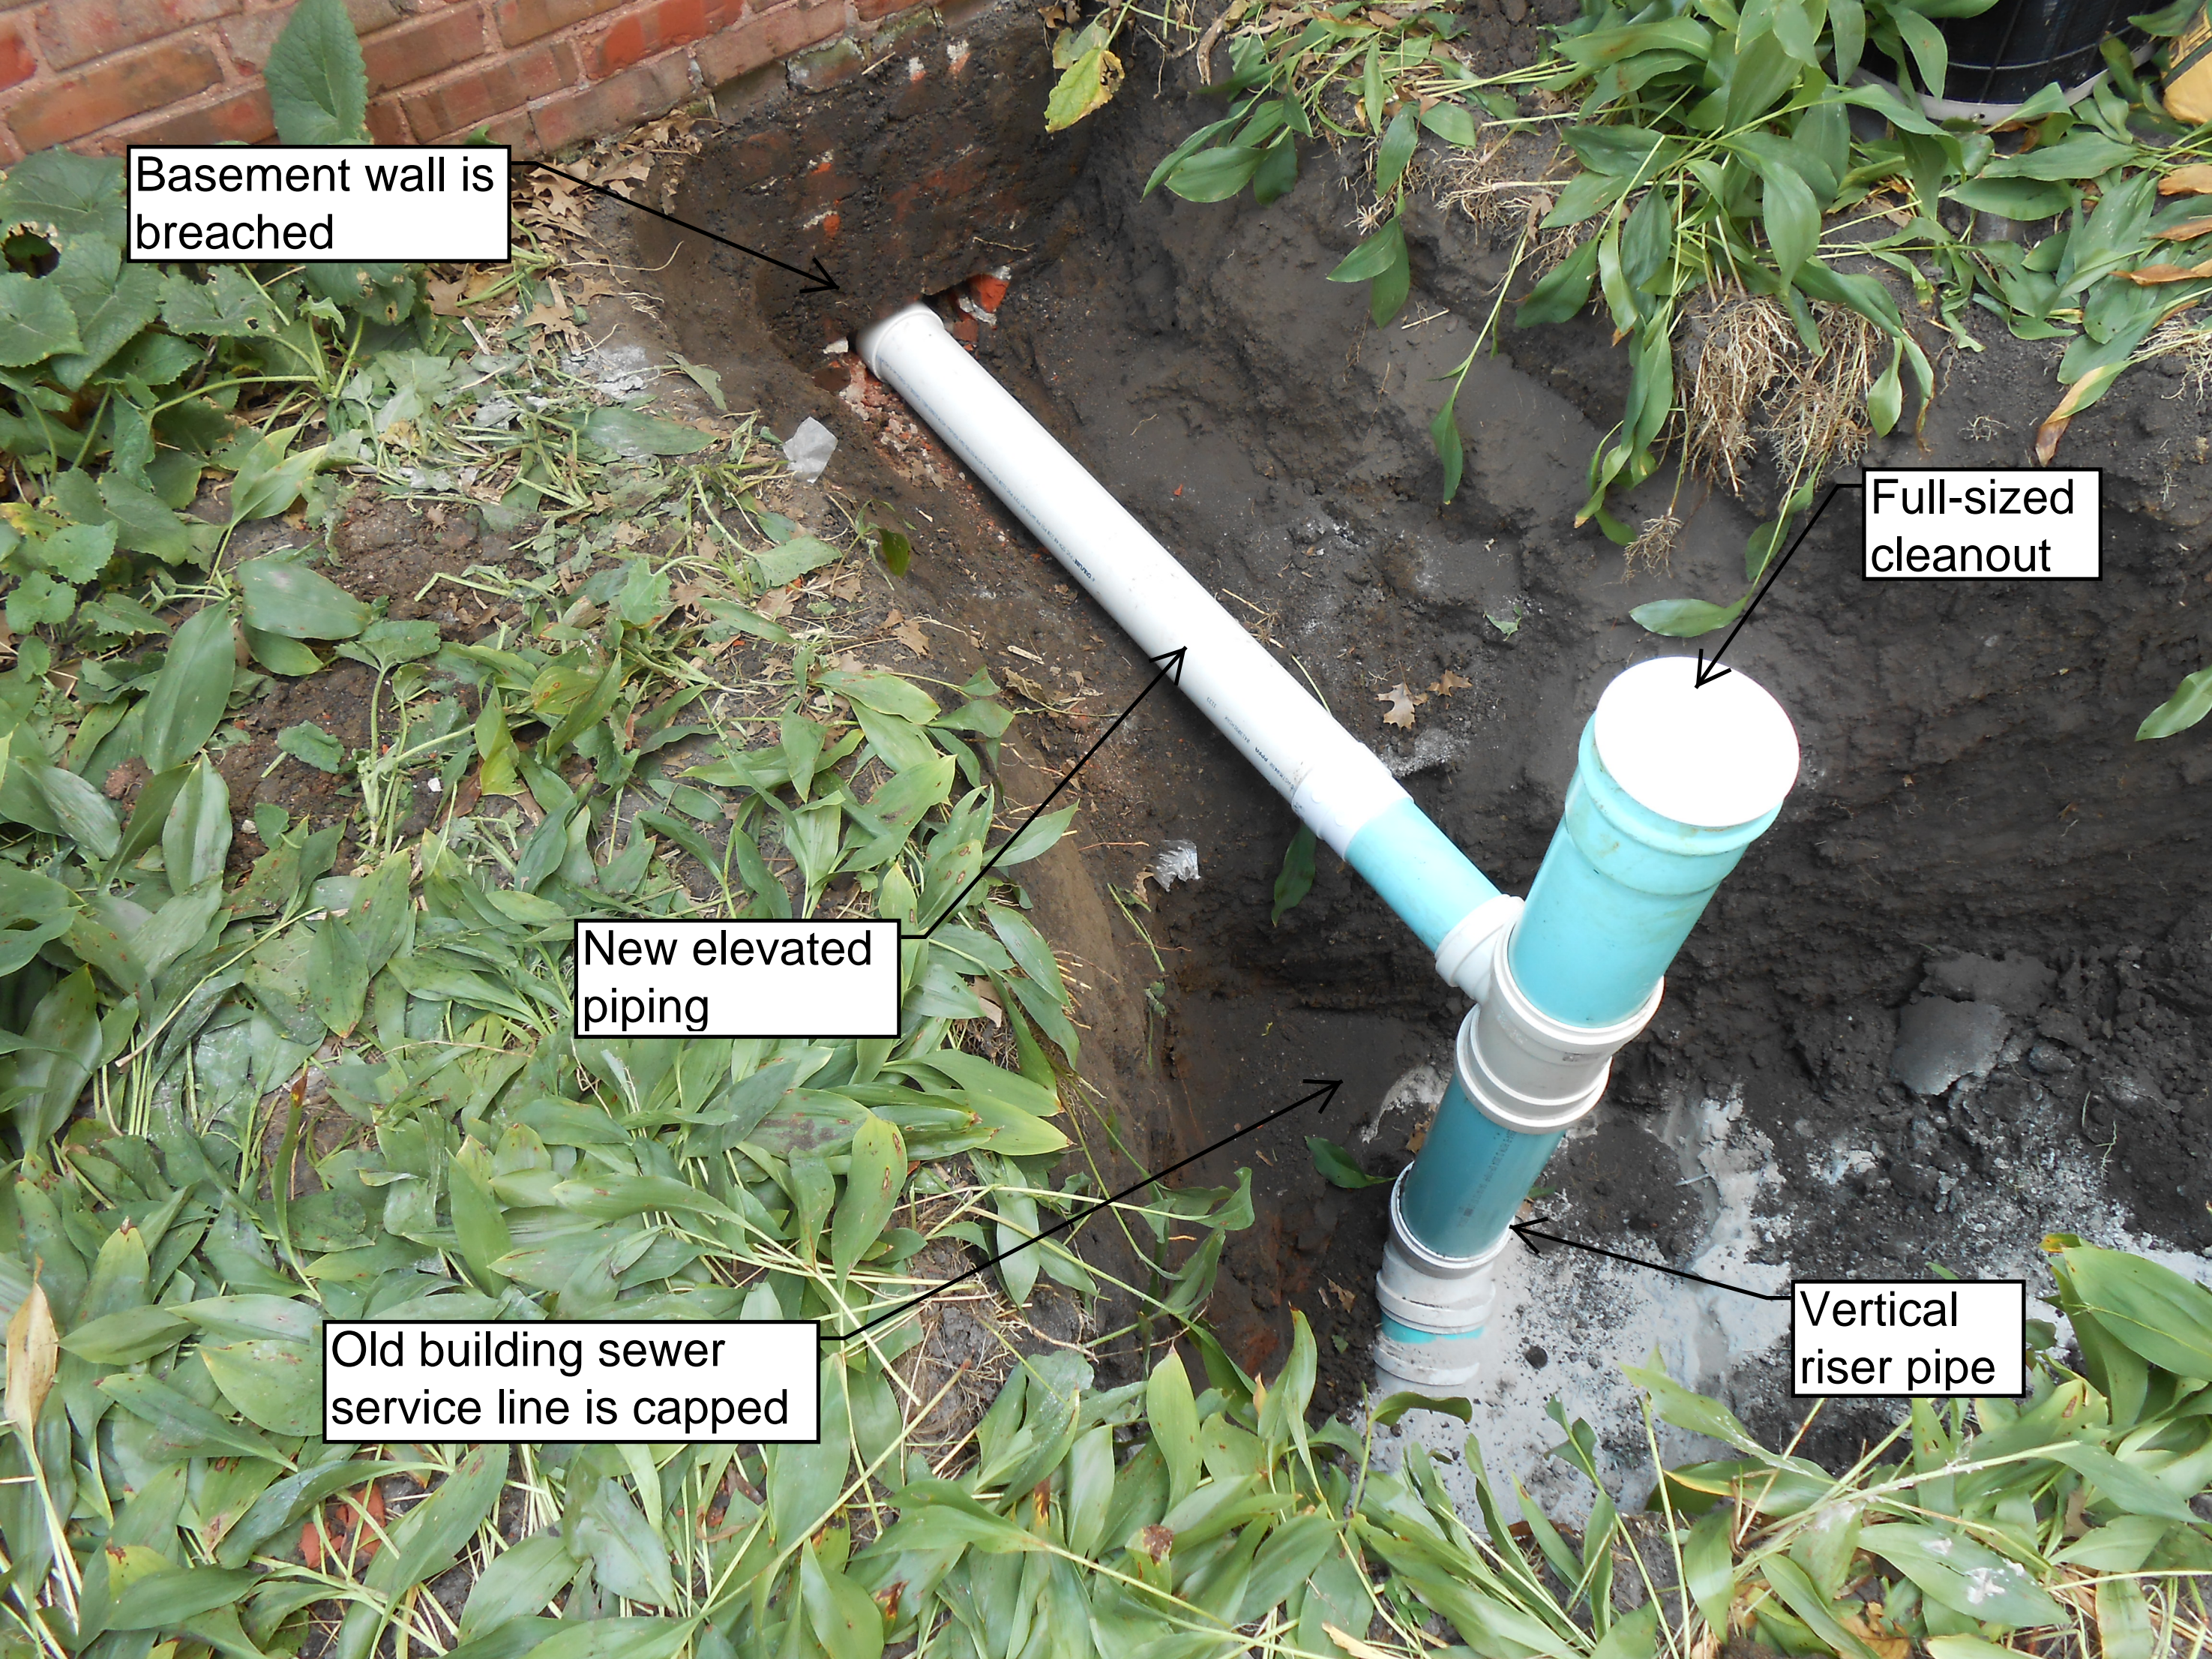
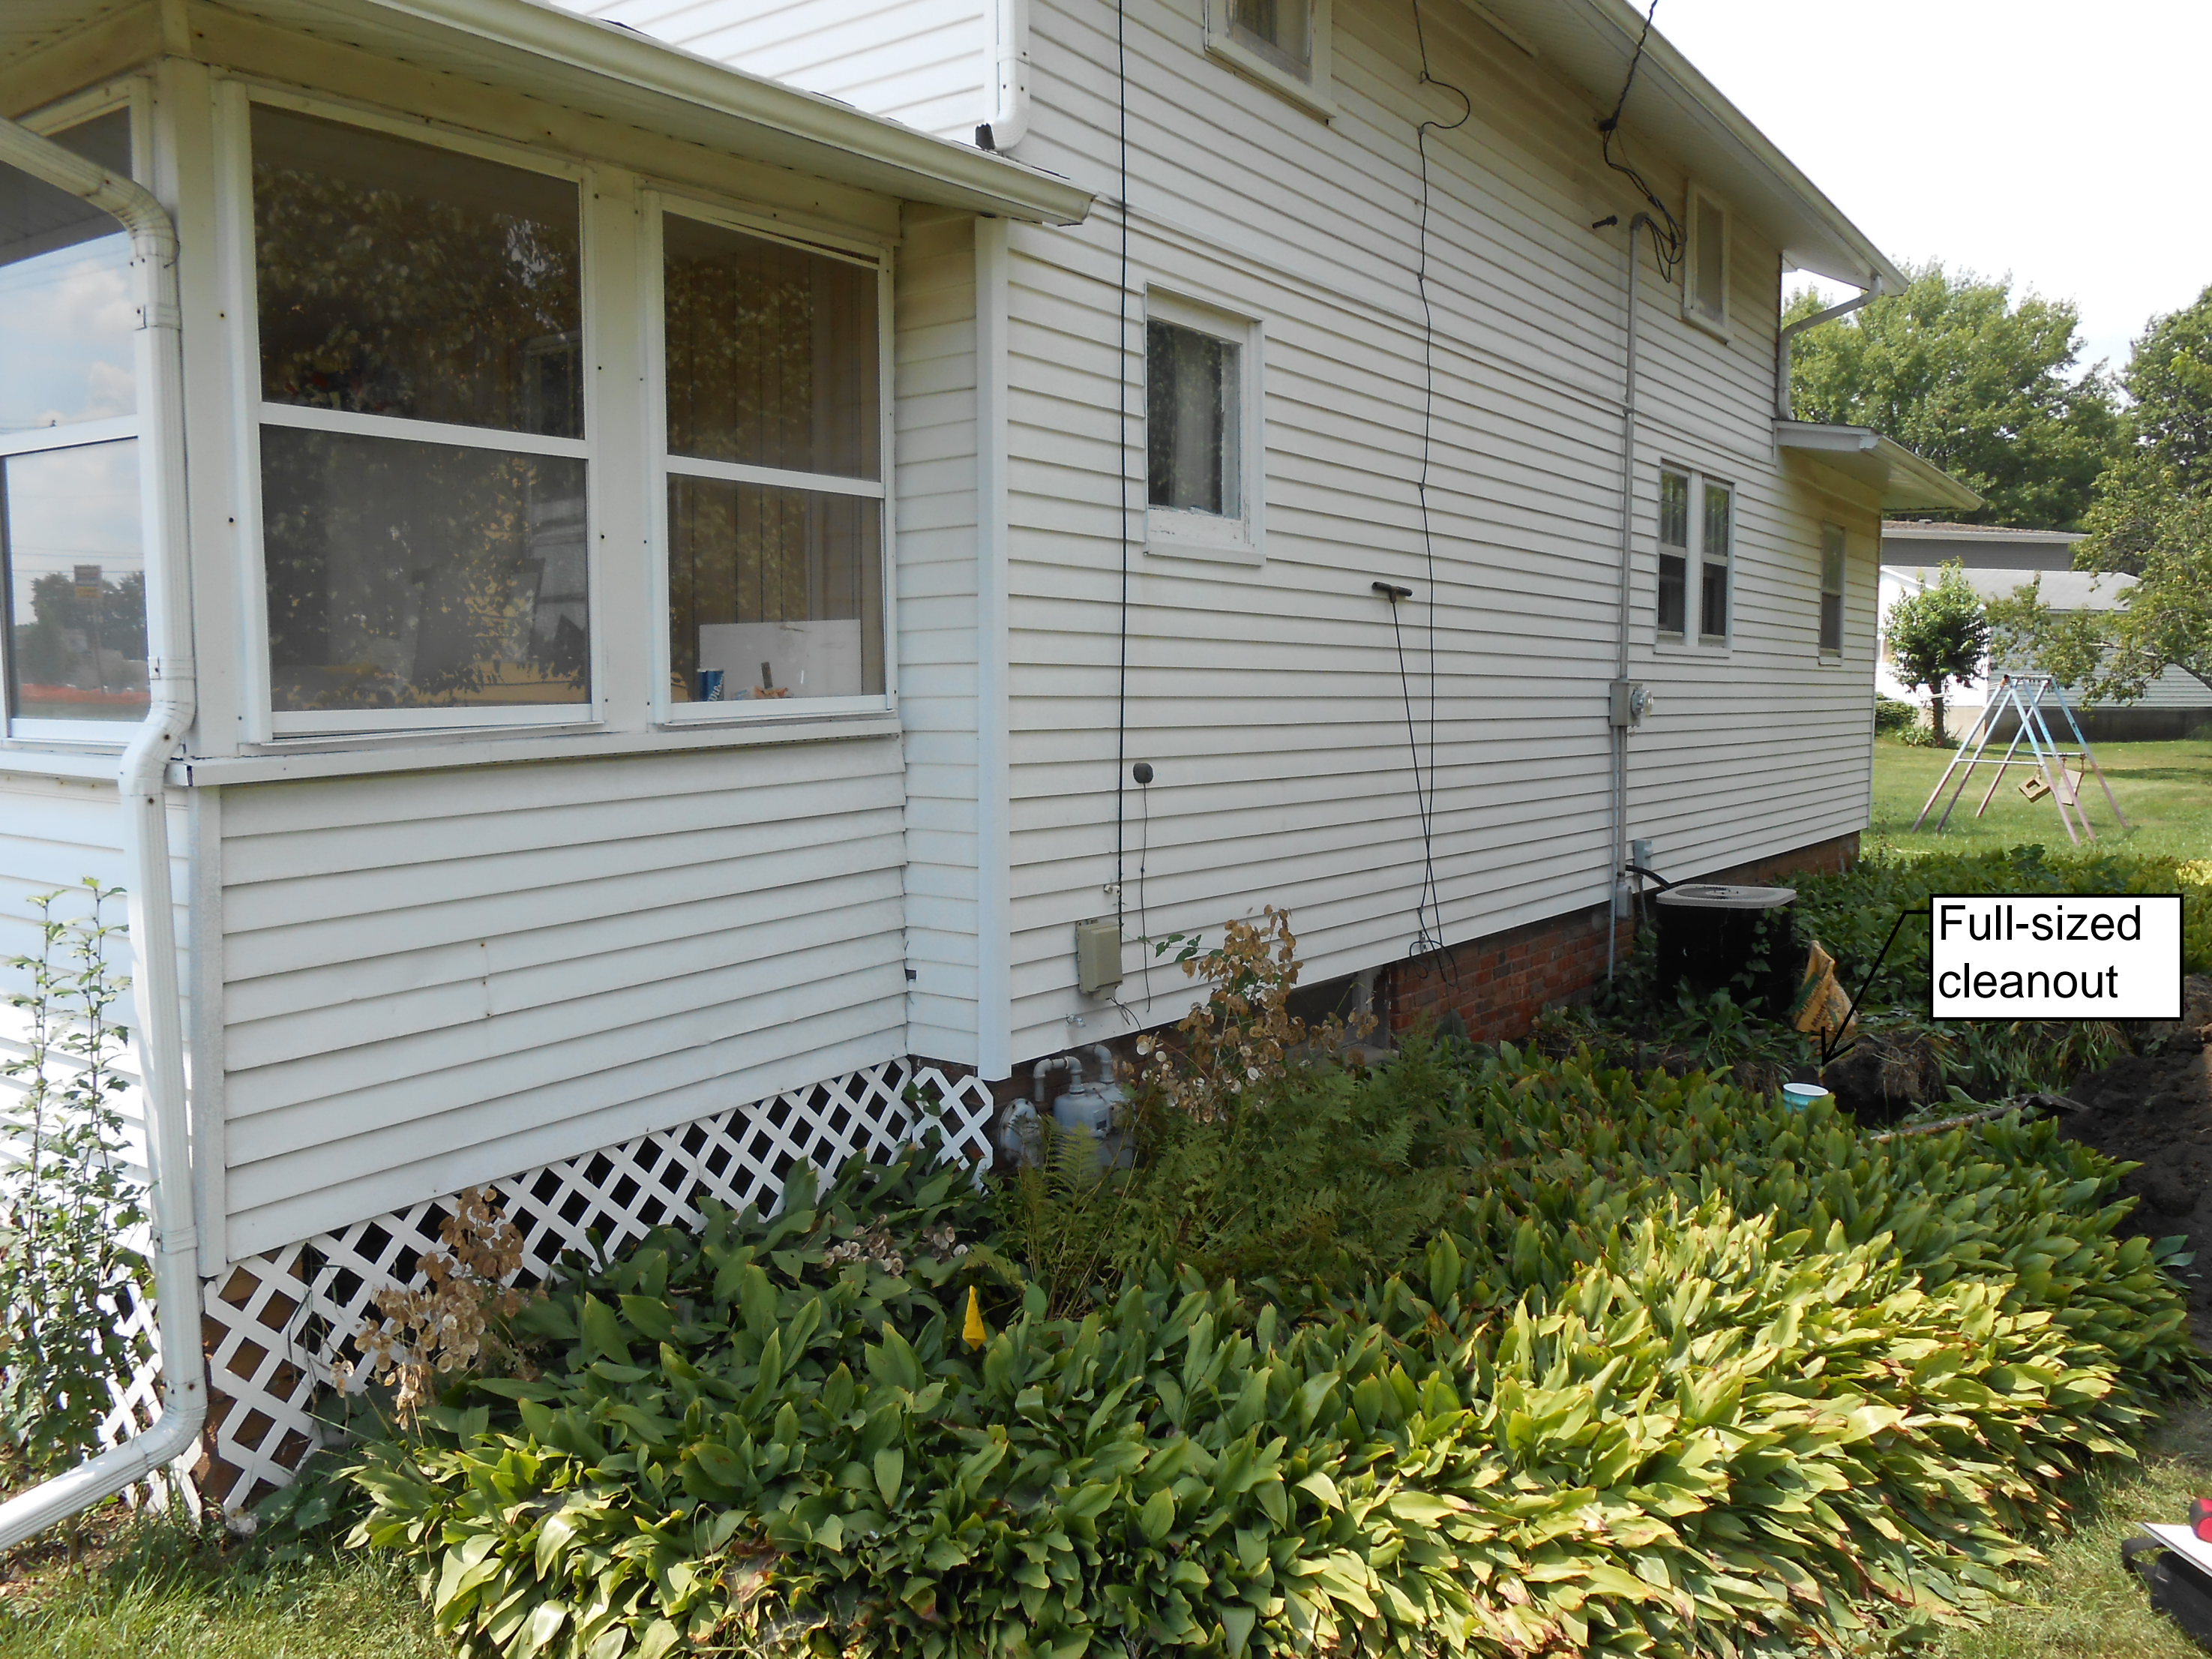
Full-sized
cleanout
